## Revision of Recalled Hip Stem, with Infection

# Grip and Polymer Cable Fixation for Inter-Trochanteric Fracture

### Femoral mid-shaft periprosthetic fracture

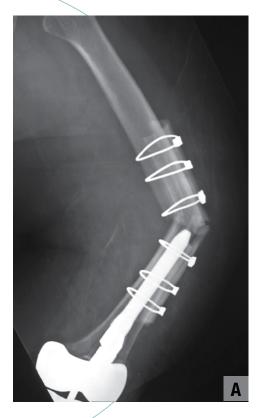
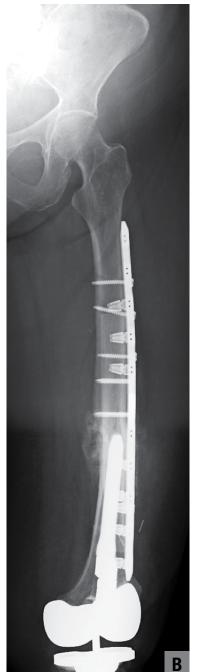
Pre-op radiograph (A) showing non-union of a periprosthetic fracture at the tip of the implant stem with failed strut allograft and metal cable fixation. Seven-week post-op radiograph (B) illustrates repair of the periprosthetic fracture with cable-plate, polymer cables, locking and compression screws, and strut allograft. Cancellous chips and platelet-rich plasma were packed around fracture site. At this time patient was fully weight bearing with evidence of good fracture consolidation.

The patient was then referred to our practice for consultation and surgery was performed. She underwent open reduction and internal fixation with reconstruction of the femur using a Kinamed cable-plate, fixed with 8 polymer SuperCables, 3 compression screws and 2 fixed-angle locking screws, augmented with a posterior cortical strut graft. Cancellous cadaveric bone chips, along with platelet-rich plasma, were packed around the fracture site.

We were able to immediately ambulate her the following postoperative day. Formal physical therapy was undertaken shortly after surgery. She was kept partial weight bearing for approximately six weeks at which time she was progressed to full weight bearing. Radiographs documented progressive callus formation and fracture healing.
